# Computed Tomography (CT) Imaging of Injuries from Blunt Abdominal Trauma: A Pictorial Essay

Blunt abdominal trauma can cause multiple internal injuries. However, these injuries are often difficult to accurately evaluate, particularly in the presence of more obvious external injuries. Computed tomography (CT) imaging is currently used to assess clinically stable patients with blunt abdominal trauma. CT can provide a rapid and accurate appraisal of the abdominal viscera, retroperitoneum and abdominal wall, as well as a limited assessment of the lower thoracic region and bony pelvis. This paper presents examples of various injuries in trauma patients depicted in abdominal CT images. We hope these images provide a resource for radiologists, surgeons and medical officers, as well as a learning tool for medical students.

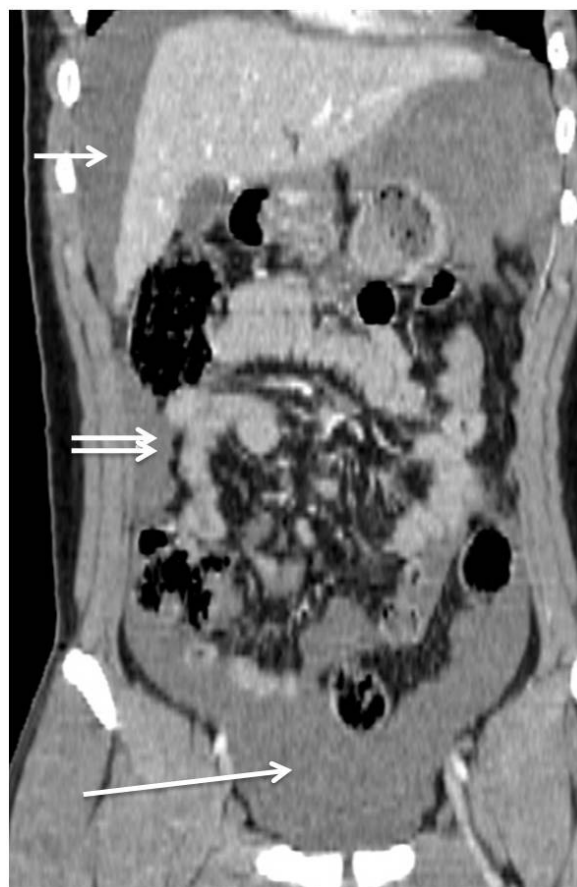
**Figure 1a:** CT coronal MPR in 18-year-old boy whose motorbike skidded. He had a Grade V splenic injury (images not shown). Splenectomy was performed and about 2 litres of haemoperitoneum was noted intraoperatively. This image demonstrate the possible pathway of blood flow, from the splenic injury to perihepatic (single arrow) regions and passes down the right paracolic gutter (double arrows) to the pelvic cavity (long arrow).

CT has high sensitivity and specificity for the detection of blood in the peritoneal cavity (15). Haemoperitoneum starts near the site of injury and spreads along the expected anatomic pathways (16). When the patient is in a supine position, blood from the liver collects in Morison's pouch and passes down the right paracolic gutter to the pelvis. From the spleen, blood passes via the phrenocolic ligament to the left paracolic gutter and the pelvis (Figure 1a). Blood from a splenic injury also goes to the right upper quadrant (16). Although peritoneal lavage is a sensitive indicator of intraperitoneal haemorrhage, it is unable to detect the source or origin of the bleeding (17). The 'sentinel clot' sign indicates adjacent, focal higher attenuation clotted blood as a marker for the organ that is the cause of haemorrhage (16) (Figure 1b). A large amount of blood may collect in the pelvis without much haemoperitoneum seen in the upper abdomen.

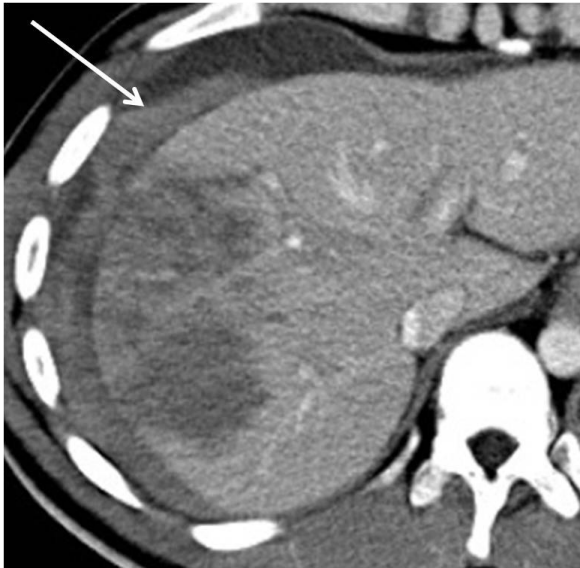
**Figure 1b:** CT scan showing haemoperitoneum from liver injury in a 23-year-old man who was involved in a motor vehicle accident (MVA). The 'sentinel clot' sign is seen as a high-attenuation collection adjacent to the liver surface (arrow). Liver injury was confirmed surgically with estimated blood loss of 3 litres.

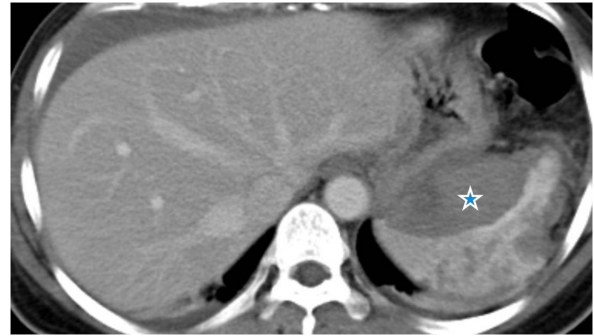
**Figure 2a:** CT scan of a 32-year-old man following MVA showing splenic injury. Subcapsular haematoma (star) appears as a region of low attenuation that compresses the normal splenic parenchyma. Note also multiple lacerations of the spleen. Splenectomy was performed in this patient.

haematoma (22) (Figures 2a, 2b and 2c). Several CT grading scales for splenic injury are available, but these grading scales have become less clinically important with the increasing popularity of non-surgical management of splenic injury (23–24). These scales are now most important for research and database use.

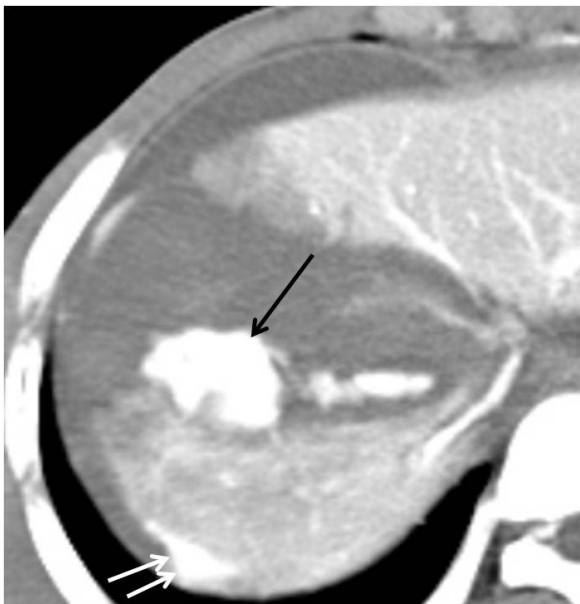
**Figure 1c:** CT scan demonstrating active haemorrhage in a 20-year-old man following MVA. CT shows contrast extravasation (long arrows) and pooling of the extravasated contrast in the dependant area (short arrows). This patient died 2 days after surgery from excessive blood loss.

Active haemorrhage can appear as a region of extravasated contrast material and is indicated on a CT scan by an area of high attenuation, with values ranging from 85 to 350 Hounsfield units (HU) (Figure 1c) (18). The site of contrast extravasations noted on CT scans corresponds to the site of bleeding seen on angiography (19).

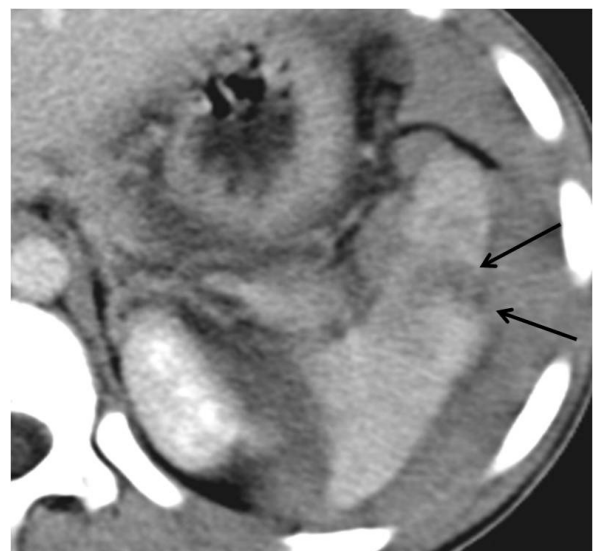
**Figure 2b:** CT scan showing splenic laceration in a 13-year-old boy, a pillion rider of a skidded motorbike. Splenic laceration is seen as irregular, linear region of low attenuation (arrows). A 4-cm laceration was identified at the tip of the spleen during surgery and splenectomy was performed.

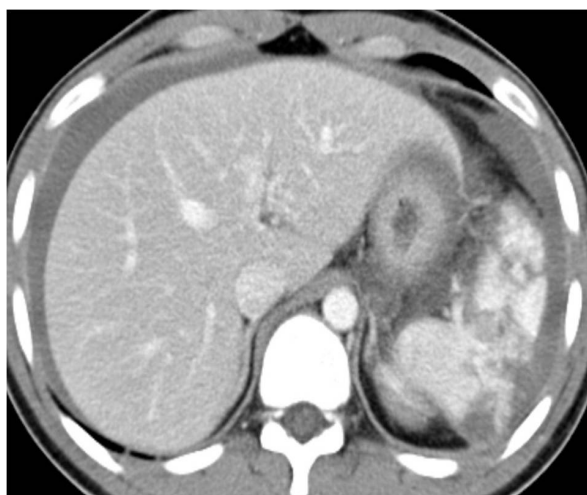
**Figure 2c:** CT scan demonstrating a shattered spleen in a 21-year-old male motorcyclist following MVA. Multiple hypodense areas that connect to the visceral surfaces are shown. This patient had failed conservative treatment and splenectomy was performed 2 days following the trauma which confirmed the CT findings of shattered spleen.

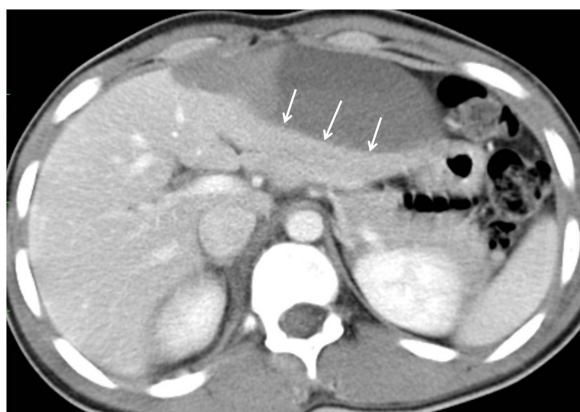
**Figure 3a:** CT scan of liver injury in a 48-year-old man with MVA. CT demonstrates a subcapsular haematoma that appears as a hypodense collection, compressing on the underlying liver parenchyma (arrows).

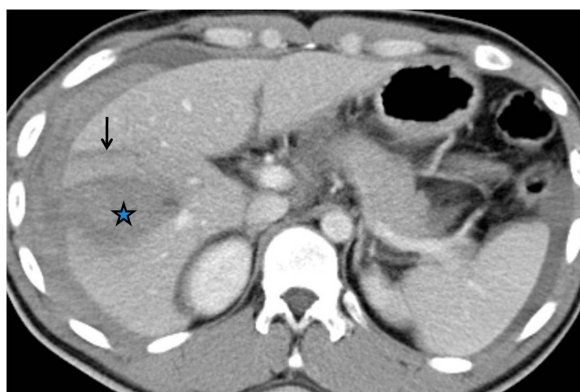
**Figure 3b:** CT scan of liver injury in a 23-year-old man with MVA. Liver laceration is shown on CT as a non-enhancing irregular, linear low attenuation area (arrow) with associated intraparenchymal haematoma (star), which appears as a region of decrease attenuation compared to the rest of the enhanced liver parenchyma. He was managed surgically.

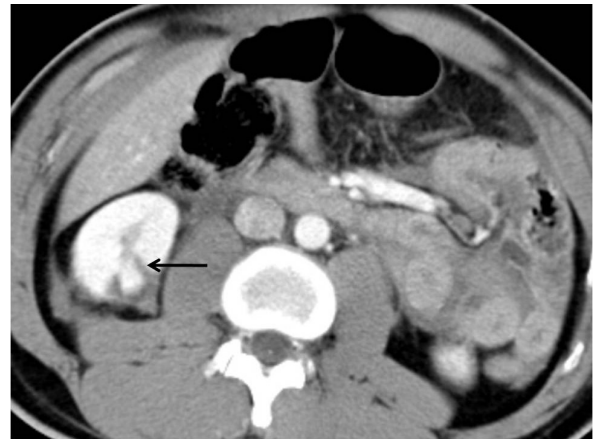
**Figure 4b:** CT of renal laceration in a 32-year-old man with MVA. The right renal lacerations are shown as irregular, linear low attenuation areas within the parenchyma (arrow), which does not involve the collecting systems. He was managed conservatively with an uneventful recovery.

Renal injury occurs in about 10% of cases of abdominal injury and the majority of renal injuries (80% to 90%) result from blunt trauma (28). CT can provide a precise delineation of renal laceration, haematoma and perinephric collection (29); in addition, CT scans can be used to differentiate trivial injuries from those requiring intervention (28) (Figures 4a, 4b and 4c).

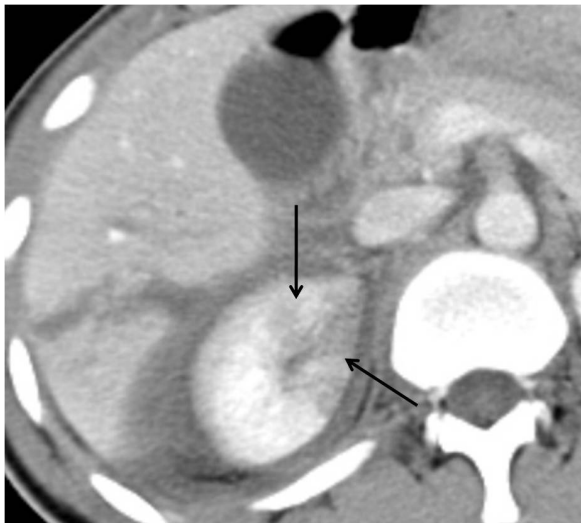
**Figure 4a:** CT scan of renal injury in a 20-year-old man with MVA. A right contusion that appears as a focal patchy area of decreased enhancement (arrows) was observed on CT. A liver laceration is present adjacent to the kidney. He was managed conservatively with an uneventful recovery.

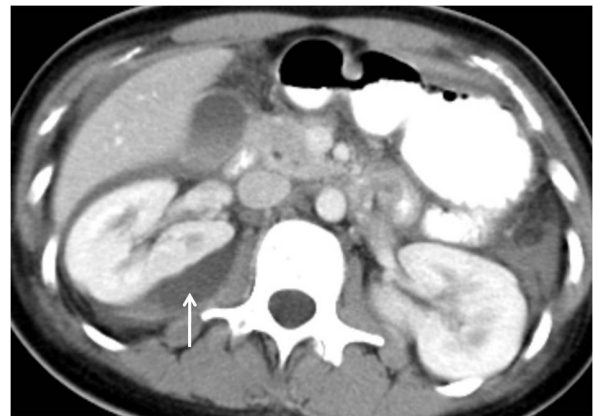
**Figure 4c:** CT scan of renal injury in a 17-year-old girl with MVA. Subcapsular haematoma of the right kidney (arrows) appears on CT as a superficial, crescentic, low attenuation area that compresses the adjacent renal parenchyma. She was managed conservatively with uneventful recovery.

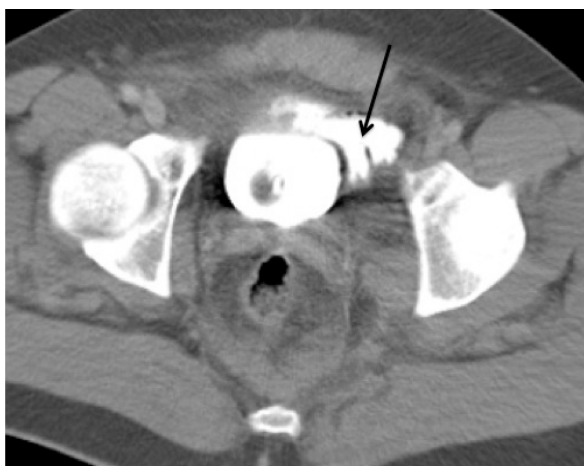
**Figure 5a:** CT cystogram of urinary bladder trauma in a 28-year-old man following MVA. There is extravasation of contrast (arrow) in the perivesical fat indicating an extraperitoneal bladder rupture.

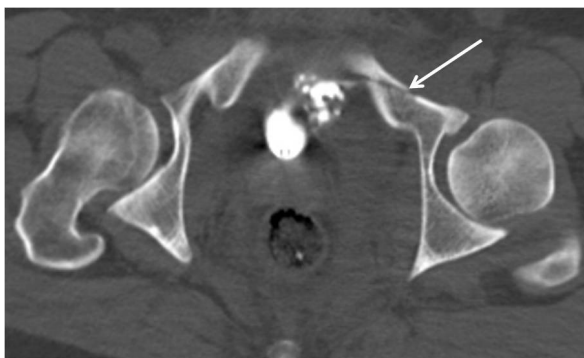
**Figure 5b:** CT scan showing fracture of the pelvic bone. A lower scan of the same patient in Figure 5a shows the pelvic fracture (arrow). He was managed conservatively with uneventful recovery.

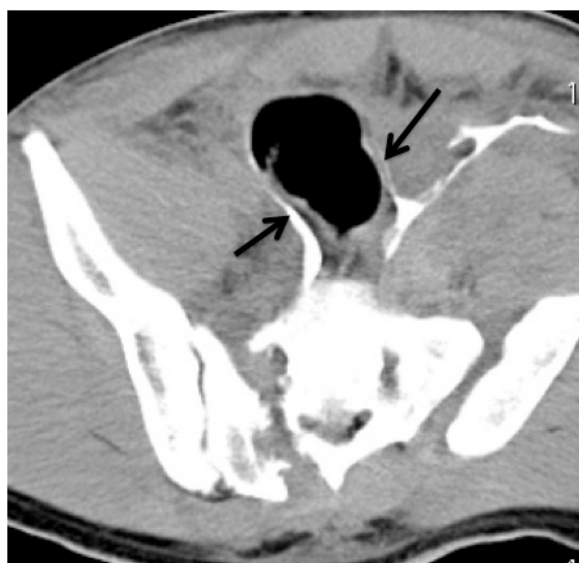
**Figure 5c:** CT scan of urinary bladder injury in a 26-year-old man with industrial accident. He fell and was run over by a tractor. This image shows extravasation of contrast from a urinary bladder injury, which outline the bowel loops (arrows). This indicates an intraperitoneal bladder rupture. Note fracture on the right side of the sacrum and diasthesis of left sacroiliac joint. Urinary bladder perforation at 2 sites with about 1 litre of haemoperitoneum was confirmed at surgery.

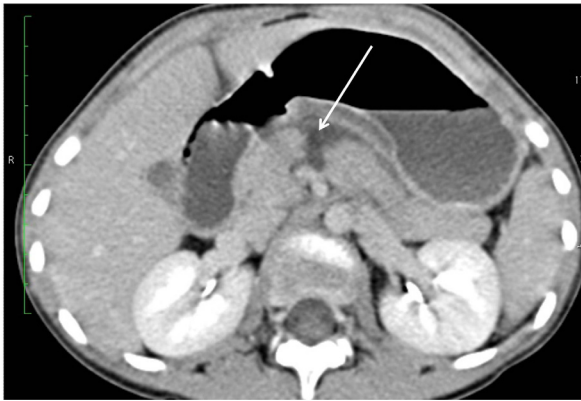
**Figure 6:** CT scan of pancreatic transection in a 9-year-old girl with ‘bicycle-handle’ injury. Diagnosis was delayed and CT scan performed 2 days after the incident showed a total transection of the body of pancreas (arrow). This was later complicated by a pseudocyst formation that required a percutaneous drainage.

Pancreatic injury is encountered in only 3% to 12% of all abdominal injuries (31). Pancreatic injury is more common in children and young adults, possibly because these individuals have less retroperitoneal fat to act as a protective buffer (2). The identification of blunt pancreatic injury may be difficult because image findings are often subtle (32). Initial CT findings may be normal, even with pancreatic transection, because the elastic pancreatic parenchyma resumes its normal contour (33). A repeated CT abdominal scan at 24 to 48 hours can help reveal evolving injuries (2). A delay in diagnosis can often result in recurrent pancreatitis, pseudocyst, fistula or abscess formation (27)(Figure 6).

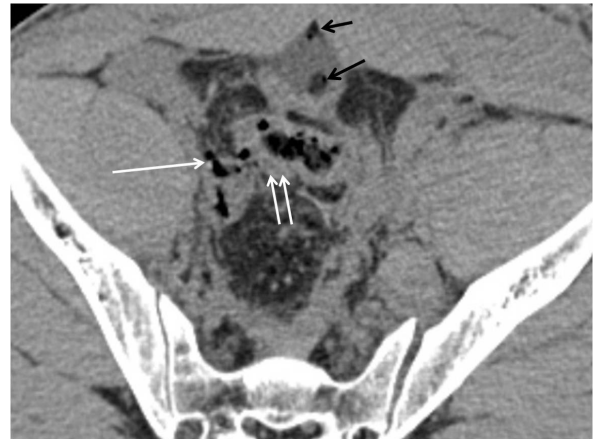
**Figure 7a:** CT scan of perforated bowel in a 26-year-old man with MVA. Note subtle extraluminal air (single white arrows) with focal bowel wall thickening (double white arrows) at the rectosigmoid region that was missed on initial review of the CT images. Also note air pockets in the urinary bladder (black arrows). Urinary bladder perforation and transection at the rectosigmoid junction were detected intraoperatively.

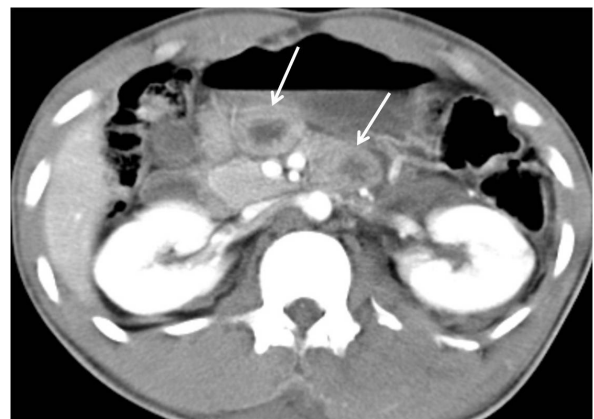
**Figure 7b:** CT scan of bowel injury in a 23-year-old lorry driver with MVA. CT scan showed focal small bowel thickening (arrows) but no free air was identified. Small bowel perforation was found intraoperatively.

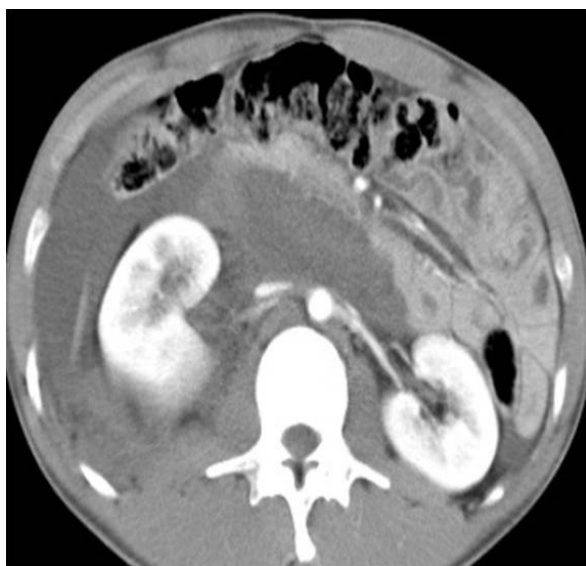
**Figure 8a:** CT scan of retroperitoneal injury in a 23-year-old man with MVA. CT shows an anterior displacement of the right kidney by a retroperitoneal haemorrhage. Both kidneys are otherwise intact. He was managed conservatively with uneventful recovery.

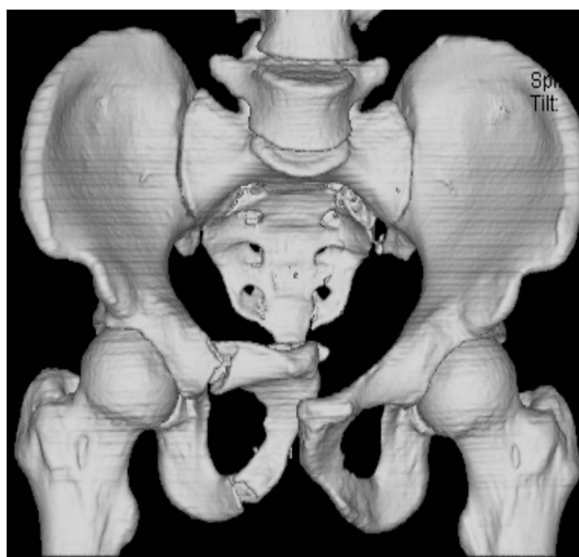
**Figure 9a:** CT scan showing fracture of the pelvic bone in a 29-year-old lorry driver following MVA. This volume-rendered CT coronal MPR image clearly depicts fracture of the right public rami with displacement of the fractured fragments.

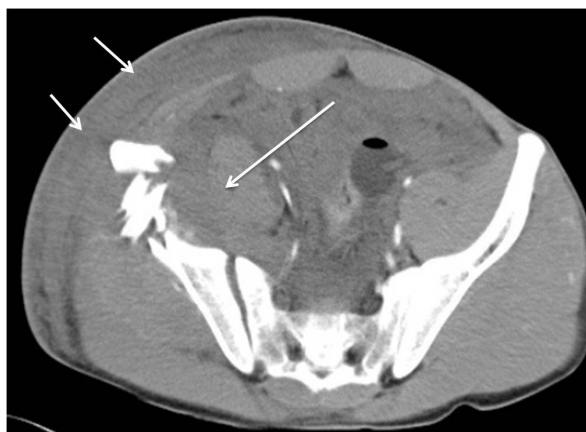
**Figure 8b:** CT scan of the same patient in Figure 8a showing the soft tissue injury. There is haematoma and thickening of the abdominal wall (short arrows). The soft tissue injury is extensive involving the right iliopsoas muscle (long arrows) and extends inferiorly to the high region, which compresses the right femoral artery and vein (images are not shown). Note also comminuted fractures of the right iliac bone.

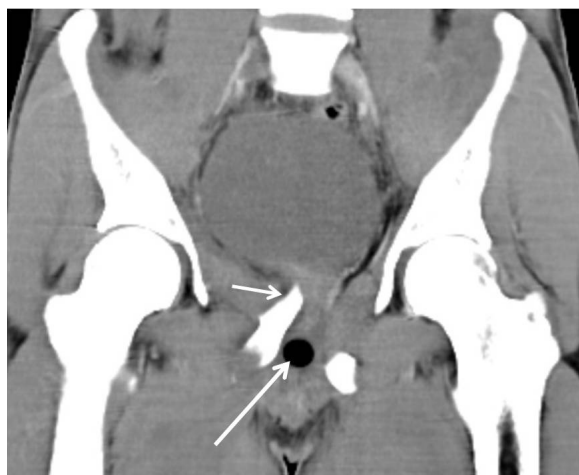
**Figure 9b:** CT demonstrating soft tissue injury associated with pelvic fracture. A coronal MPR CT image in soft tissue window of the same patient in Figure 9a showed the fractured fragment (short arrow) compressing at the base of the urinary bladder. Note the mal-positioned Foley's catheter balloon within the urethra (long arrow). Urethrogram demonstrated a membranous urethral injury.

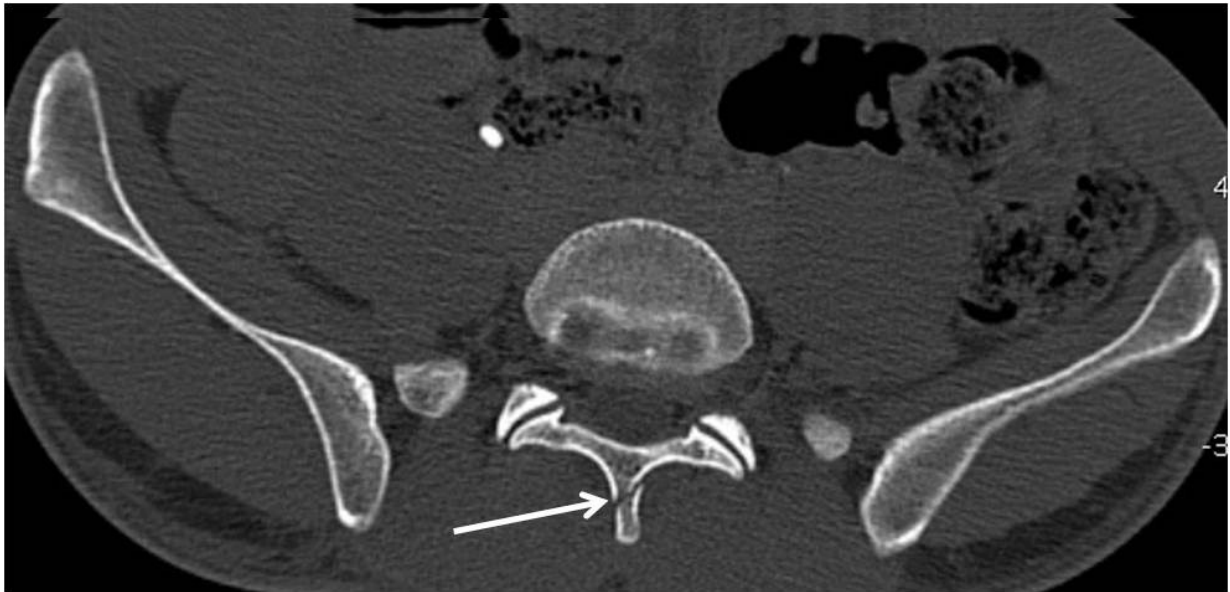
**Figure 10:** CT scan of spine fracture in a 29-year-old man who fell from height at the workplace. He complained of pain at the lumbar region. CT scan shows no intra-abdominal injury but demonstrated a subtle of L5 spinous process (arrow), which was missed on the plain radiograph. He was managed conservatively with uneventful recovery.

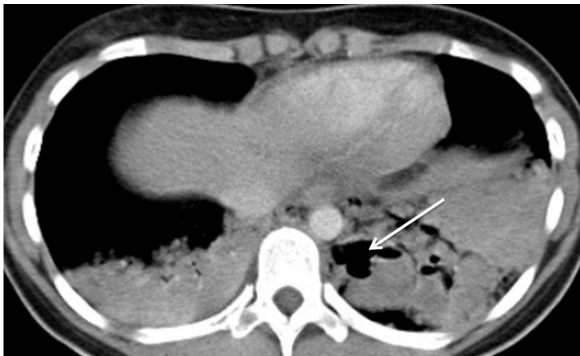
**Figure 11a:** CT of a 15-year-old boy with MVA. The limited evaluation of the lung bases reveals bilateral lung contusions with a left lung laceration (arrow). He sustained a Grade 1 liver injury (not shown) and was managed conservatively.

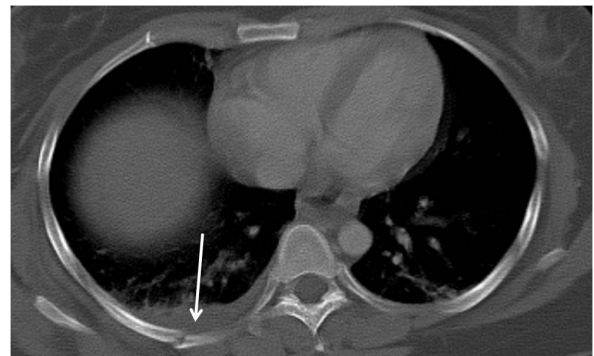
**Figure 11b:** CT evaluation of the lower thoracic region in a 25-year-old man with MVA revealed fracture of right posterior rib (arrow) with associated pleural effusion, possibly a haemothorax.
